Manhole Inspection Summary

Manhole # S51C__020MH

Insp Date: **5/1/08 9:22 AM**

Location Address: **40 n streeper st**

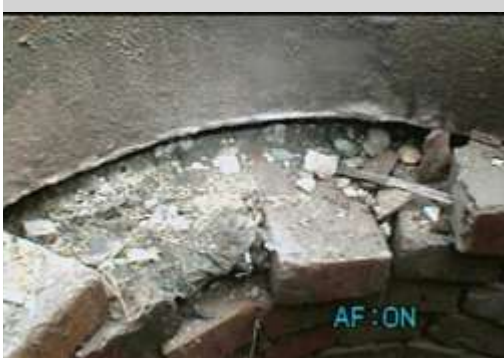
Defect 1

Frame Offset: **5** (in.) Condition: ☒ Sound ☐ Cracked ☐ Leaks

Condition: ☐ Sound ☐ Cracked ☐ Root Intrusion ☒ **Loose Brick** ☒ **Deteriorated**

frame offset, chimney has loose brick & is deteriorated

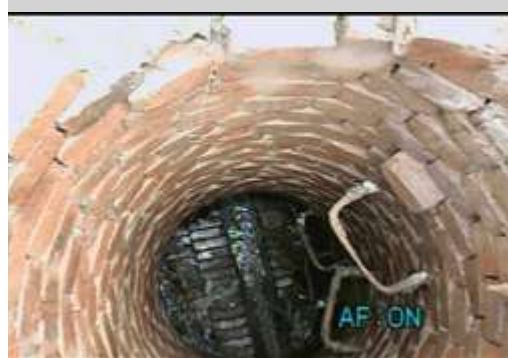
Defect 2

Condition: ☐ Sound ☐ Cracked ☐ Root Intrusion ☒ **Loose Brick** ☐ Deteriorated

Steps Count: **6** Missing: **1** ☒ **Corroded**

loose brick in corbel, corroded/missing steps

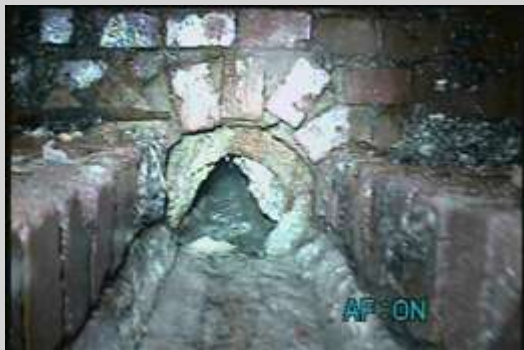
12 O'Clock Outflow

Deposits: ☐ None ☐ Mud ☐ Sludge ☐ Debris ☒ Grease

Silt Depth: 0 (in.) Deposits Extent: **Medium**
